Pipe failure

A HRL case study

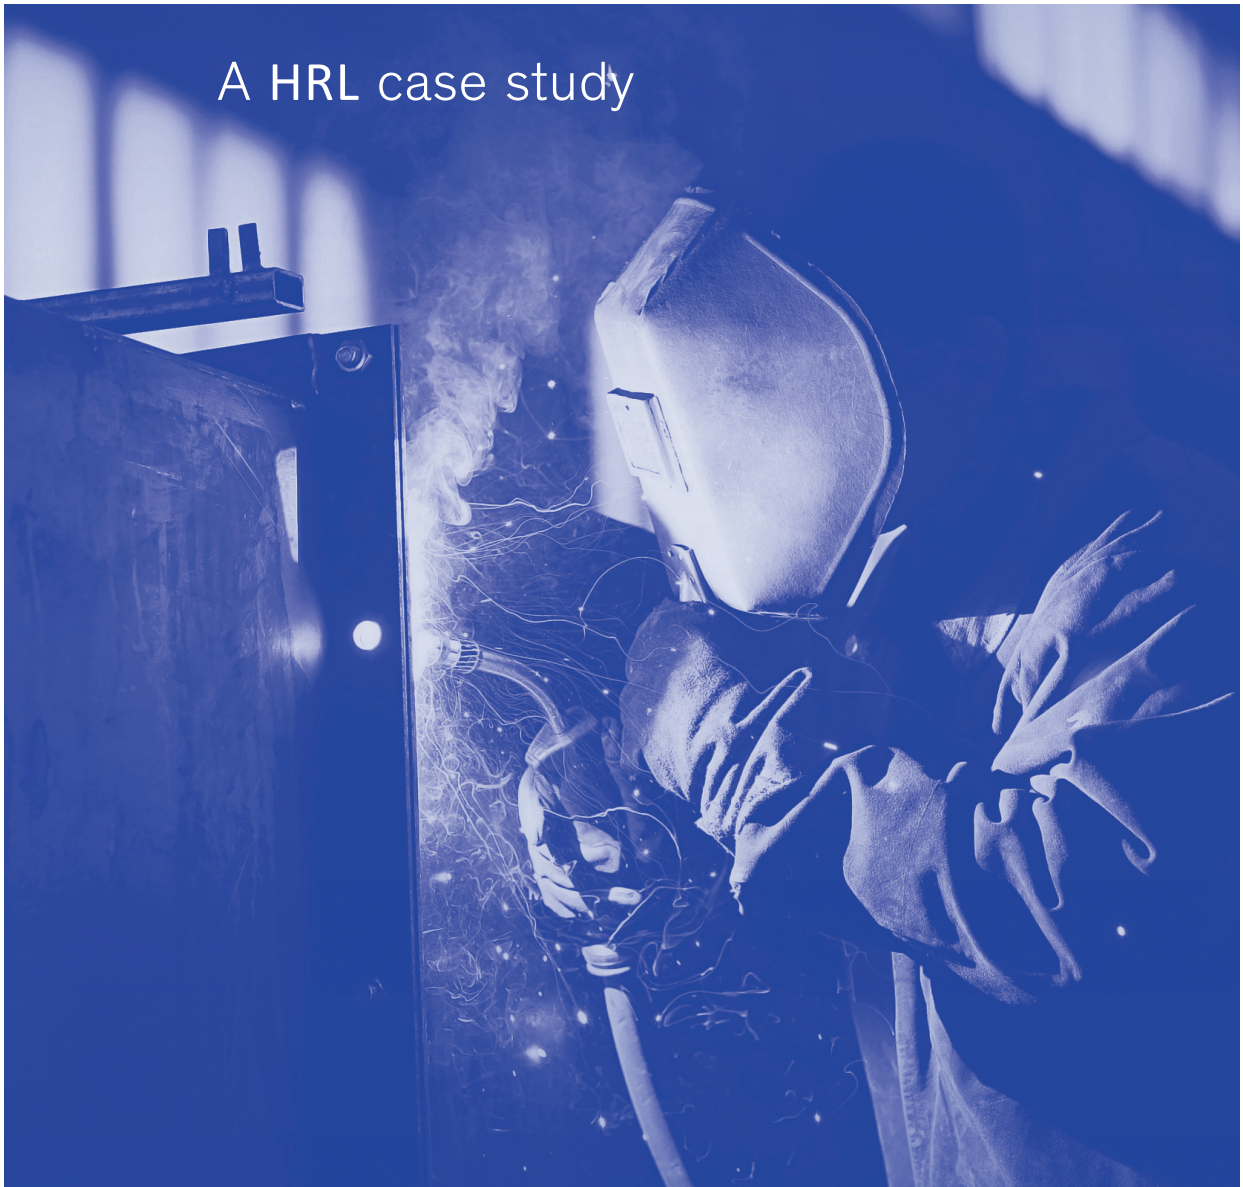
A 250 mm diameter alloy steel main steam pipe containing superheated steam failed leaking high temperature steam onto a walkway.

The failure mechanism was determined to be creep fatigue, a mechanism that is a combination of creep (a high temperature strain dependent process) and fatigue (a repetitive cyclic loading issue). A piping flexibility analysis confirmed that the location where the crack was, was outside design limits and also indicated one other location where damage could develop and where damage was subsequently detected.

This crack was through wall and extended 60% around the steam pipe. Repair required the design of a suitable pipe support and the development of a welding procedure. HRL Technology Group then provided the supervision to ensure the weld repair was undertaken according to the procedure and to the highest practicable standards.

The root cause of the failure was determined to be creep fatigue and that the extent of the crack necessitated a major weld reinstatement.

HRL's supporting piping flexibility analysis confirmed that the crack location was indeed highly stressed due to a malfunctioning hanger but that there was a second pipe termination weld that was also highly stressed. Subsequent inspection found the beginnings of a crack at this location.

The leaking crack required a major repair which was completed in a timely fashion and when non-destructively inspected after post weld heat treatment was found to be free of any significant defects.
