# Pipe failure

A hrl: case study

## From oil and gas fields around Moomba in SA, Santos recovers natural gas liquids via a refrigeration process.

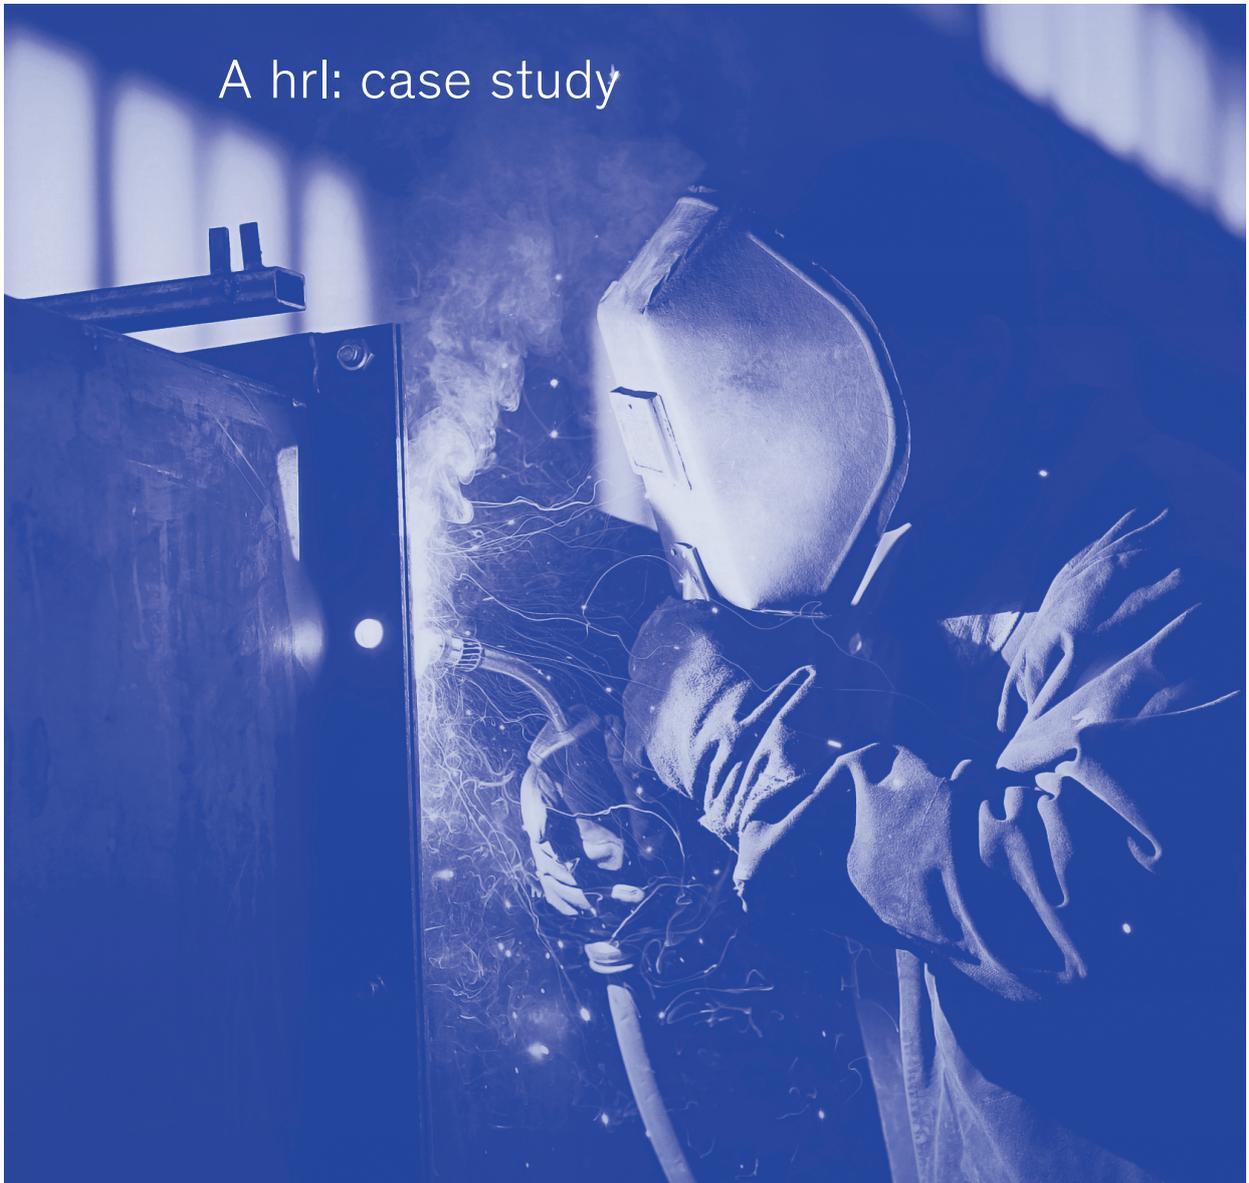
A 250 mm diameter alloy steel main steam pipe containing superheated steam failed leaking high temperature steam onto a walkway.

The failure mechanism was determined to be creep fatigue, a mechanism that is a combination of creep (a high temperature strain dependent process) and fatigue (a repetitive cyclic loading issue). A piping flexibility analysis confirmed that the location where the crack was, was outside design limits and also indicated one other location where damage could develop and where damage was subsequently detected.

This crack was through wall and extended 60% around the steam pipe. Repair required the design of a suitable pipe support and the development of a welding procedure. hrl: Technology Group then provided the supervision to ensure the weld repair was undertaken according to the procedure and to the highest practicable standards.

The hrl: Technology Group's supporting piping flexibility analysis confirmed that the crack location was indeed highly stressed due to a malfunctioning hanger but that there was a second pipe termination weld that was also highly stressed. Subsequent inspection found the beginnings of a crack at this location.

The leaking crack required a major repair which was completed in a timely fashion and when non-destructively inspected after post weld heat treatment was found to be free of any significant defects.
